OFFSHORE FAILURE INVESTIGATION

**INDEPENDENT INVESTIGATION INTO THE FAILURE OF
GAS COMPRESSION SYSTEM VENT LINE**

DOCUMENT KLC002

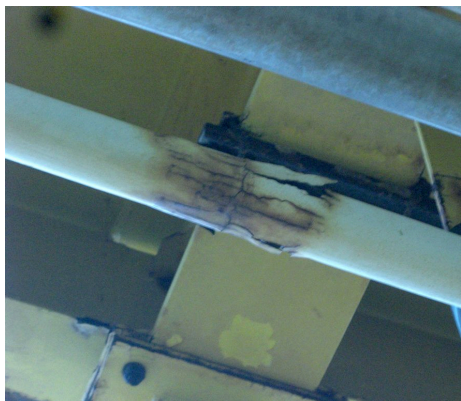
Figure 1: Original Visual Inspection

The failed segment of the vent line appears to have undergone external corrosion at a rather more localised segment of the line. The photograph in Figure 1 below illustrates, from the original visual inspection four years prior to the failure event, the localised nature of the degradation very clearly. It is particularly interesting to note the presence of circumferential as well as longitudinal cracking and spalling of the external coating system; in particular, the circumferential cracking of the external coating system appears to be continuous (although it is not possible to confirm whether this extended around the circumference in its entirety), which appears to suggest the presence of a circumferential surface discontinuity which when coated has led to inherent coating weakness and eventual breakdown. In this instance, it is suspected that the circumferential discontinuity is a weld along the pipe run; external welds can be very difficult surfaces to coat and may result in the presence of inherent coating holidays or other localised areas of weakness where coating breakdown can originate. It is postulated therefore, that the coating breakdown originated as a consequence of circumferential coating breakdown, which propagated further as time progressed and led to longitudinal cracking and spalling of the coating system and corrosion of the underlying steel.

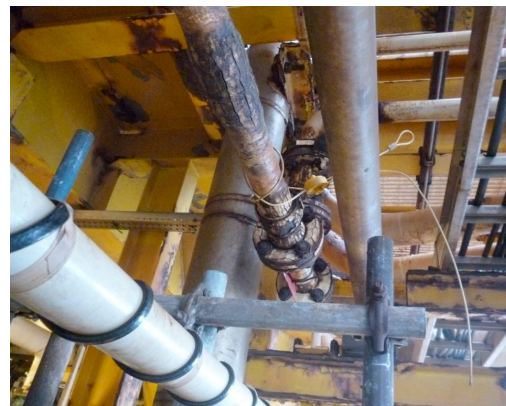
Figure 2: Visual Inspection on Failure

Figures 2 and 3, which highlight the condition of the vent line subsequent to the failure, clearly illustrate substantial deterioration within the intervening period since the original visual inspection was carried out. Figure 4 illustrates the temporary composite wrap that was recently installed.

2. The failure of the vent line occurred as a consequence of external corrosion.
3. The failure was manifested as two relatively sizeable holes of circa 40mm x 40mm and 60mm x 35mm; the orientation of the holes was top-of-line on a horizontal segment of the vent line. The general vicinity of the failure was observed to have corroded externally where the anti-corrosion coating system had degraded leading to the subsequent corrosion of the underlying steel; relatively thick and tenacious corrosion product films had developed also.
